## Extreme Dry Conditions During Installation

## WOOD MOISTURE CONTENT BY AREA

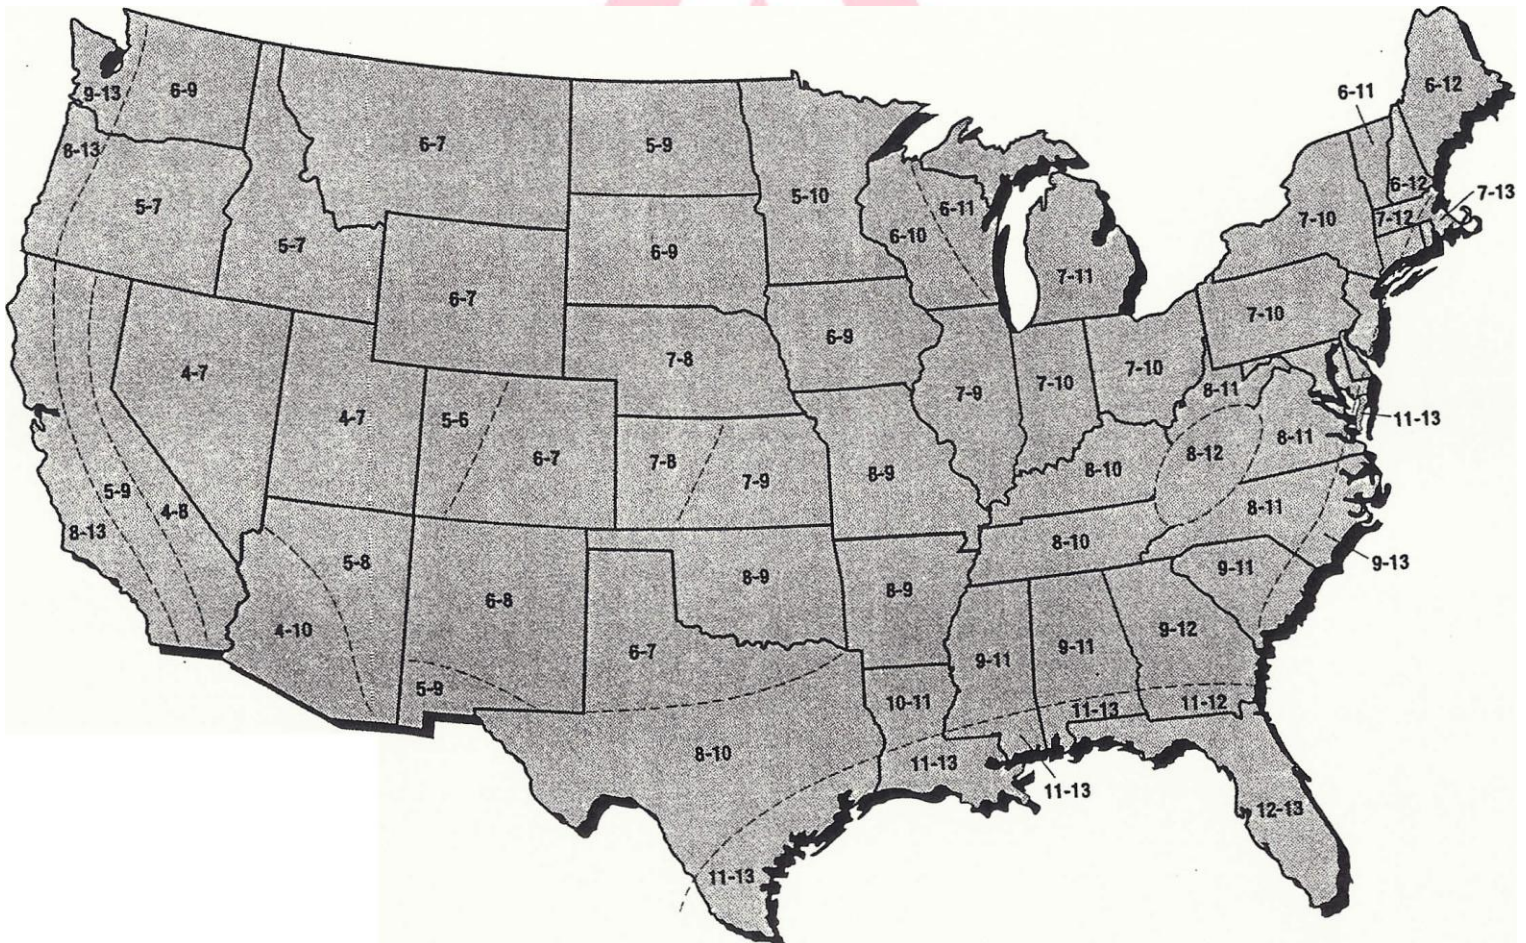
Variation of average moisture content for wood used indoors:

For each set of figures: The first number represents the average moisture content measured during January, and the second figure is, the average moisture content during July.

The region of the country, available mechanicals, and expected operation of the mechanical units, determines the expected wood moisture content range for the occupied facility. The attached USDA map provides a general range of wood moisture for each region of the country.
